Case Study:	HSC/S 1
Location:	Stephenson Drive Leicester
Client:	Leicester City Highways
Contract Date:	January 2011
Engineer:	Mr Nigel Goshawk

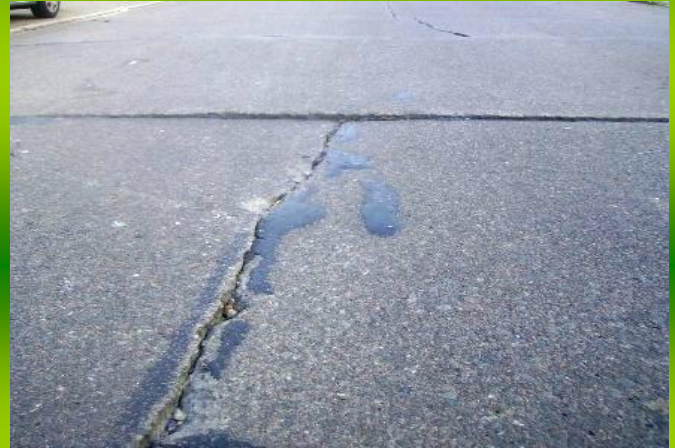
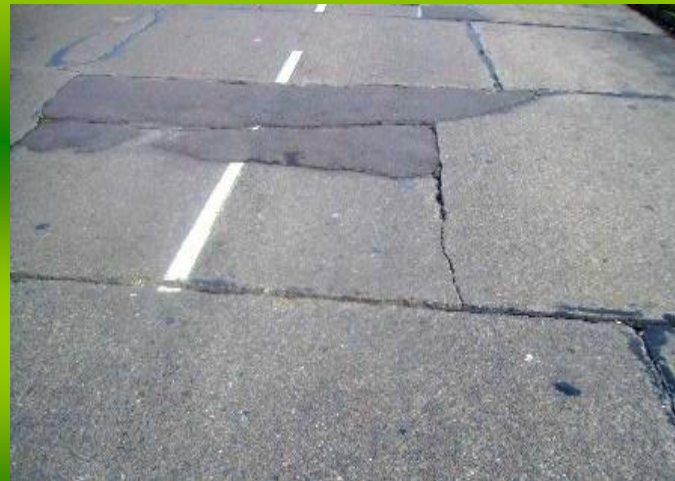
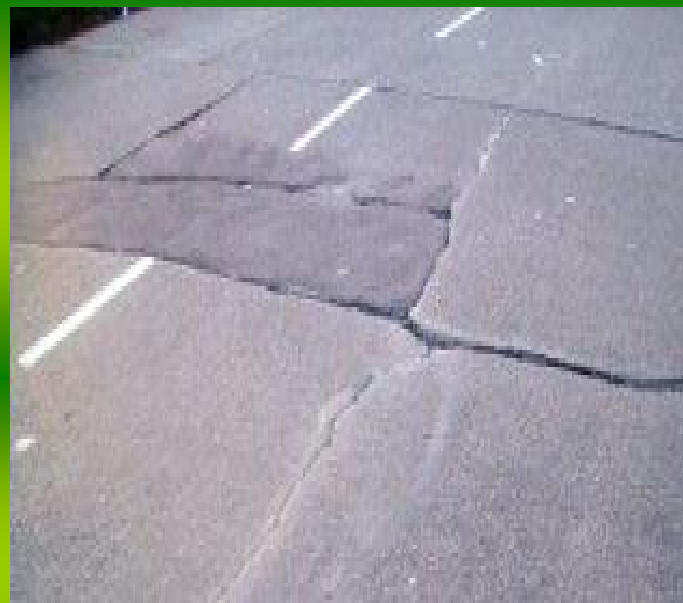
Stephenson Drive had a major problem of moving and rocking road slabs making it impossible to simply resurface it without reflective cracking appearing almost immediately.

Over time as a result of poor support under the existing carriageway due to foundation damage from poor drainage and general deterioration of the concrete, a large number of bays had failed. They had either heavily cracked or the bays that had not failed were significantly moving when vehicles travelled over them.

In order to stop the concrete slabs from moving and also to reduce the effects of horizontal and vertical movement it was decided to consolidate the ground and concrete slab”.

Mr Goshawk continues, “This was carried out using a cracking and seating process, once the ‘crack and seat’ works had been completed the surface was used in its current state for nearly 3 months before being overlaid with a new road surface. ‘Crack & Seat’ used minimal traffic management with the road remaining open as the work commenced and the cracked surface could be driven on by vehicles without any problem.” The surface had an asphalt regulating course 20mm in thickness, an asphalt grid was then placed on top of this with a bituminous bond coat and this was then overlaid with a further 50mm of asphalt material.

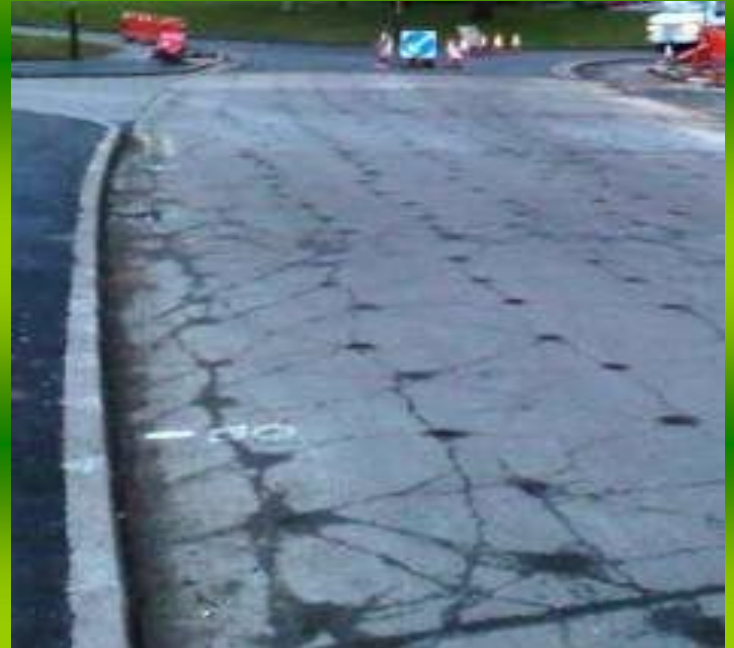
“It is hoped that by using the ‘crack and seat’ process the asphalt pavement life will have been increased by up to 10 years, and by using asphalt reinforcement a further 10 years may be expected.

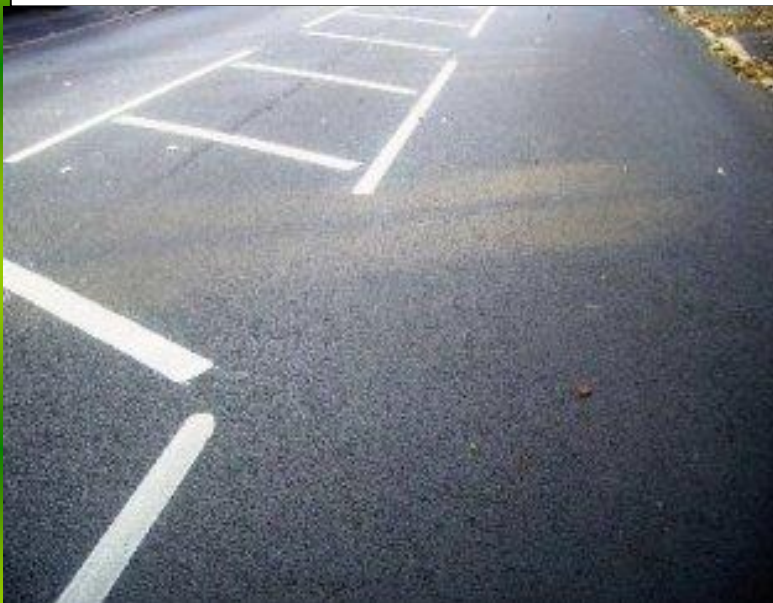
“In summary using ‘crack and seat’ has allowed us to re-use the existing failed carriageway without the need for removing it. The ground has been consolidated and a thin surface over laid to provide a new running surface.

Stephenson Drive looks like a brand new road and it is also a smooth and quiet running surface.
